**Phase I Environmental Baseline Survey:  
Building 825,  
Hill Air Force Base, Utah**

December 28, 2009

**Department of the Air Force  
Air Force Materiel Command  
Hill Air Force Base, Utah 84056  
December 28, 2009**

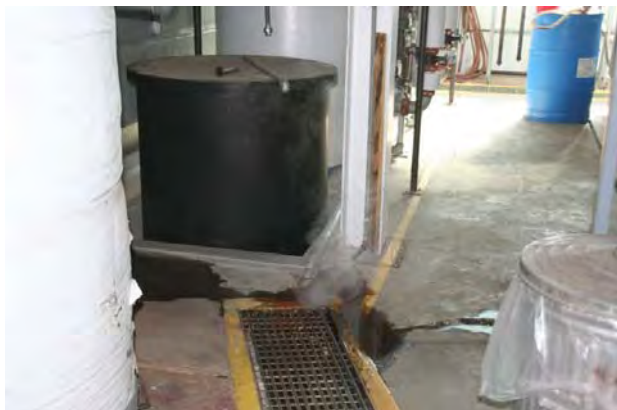
Brine tank, water entering floor drain

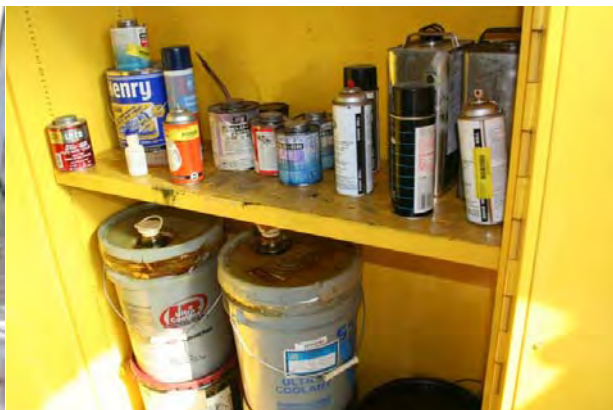
Hazardous material storage

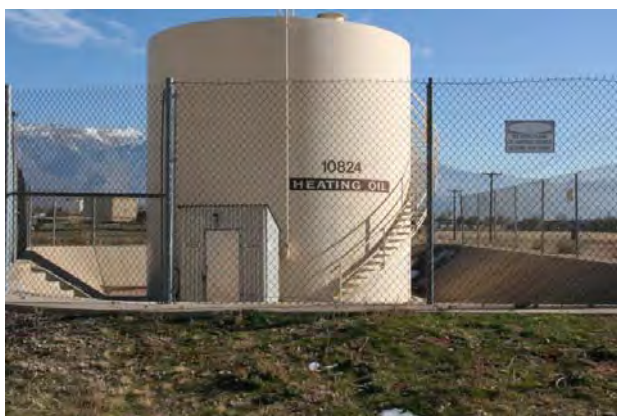
Three above ground storage tanks (ASTs) were observed during the site visit. Heating oil storage tank 10824 has a capacity of 80,000 gallons. Heating oil storage tank 10826 has a capacity of 66,000 gallons. These two ASTs are positioned over concrete secondary containment structures. One 250-gallon diesel AST is present to fuel the emergency generator. This tank is encased within concrete, providing its own secondary containment.

One of two large oil tanks

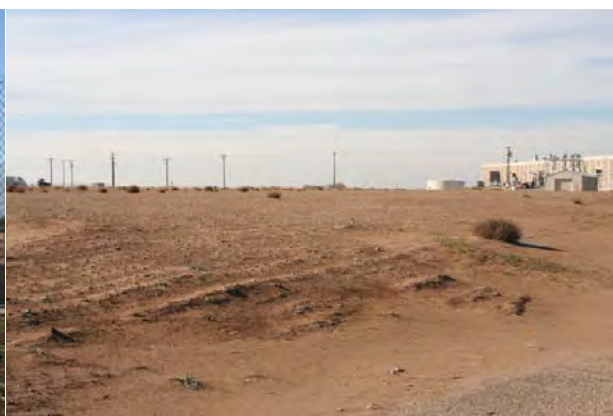
Area where Building 820 formerly existed

Building 820 has been demolished and removed. When the foundations were removed, no transite pipe (ACM) was observed.

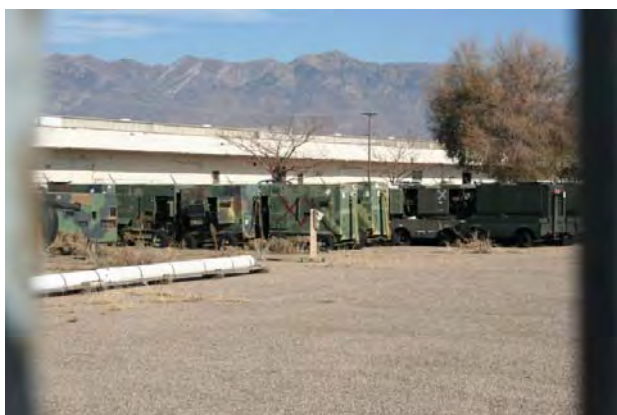
DLA storage, adjacent property to the east

- Assets stored in the lot - Majority are aircraft parts
- If there are drips or leaks of oil, etc, DLA/DDHU is responsible for clean-up
- Comments go back to 1991 when DRMD 902 took effect.

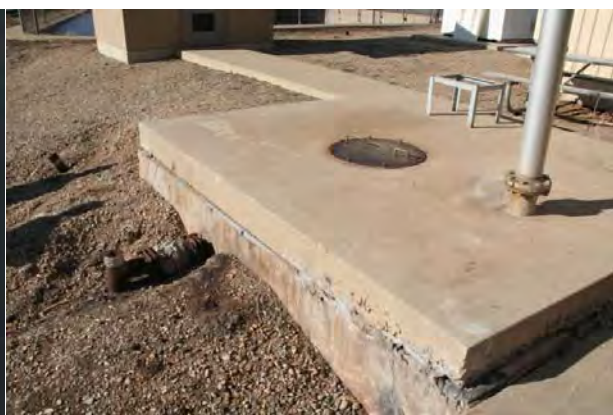
Access manhole to boiler blowdown sump

Hazardous Waste: boiler blowdown consists of solids and liquids. Solids are trapped in a sump, which is cleaned once every several years. A contractor removes the solids and transports them off-base for proper disposal. Liquids flow to the sanitary sewer lines. There is 1 can for collecting used rags, which are collected and laundered on base. Any used oil is sent for recycling. When preventive maintenance and repairs are performed on the emergency generator, all waste is removed from the building by the maintenance crews for recycling, treatment, or disposal.
